Increasing Impact Insulation Ratings in Occupied Condominiums

Scott Harvey and Josh Curley, Phoenix Noise & Vibration, Frederick, Maryland

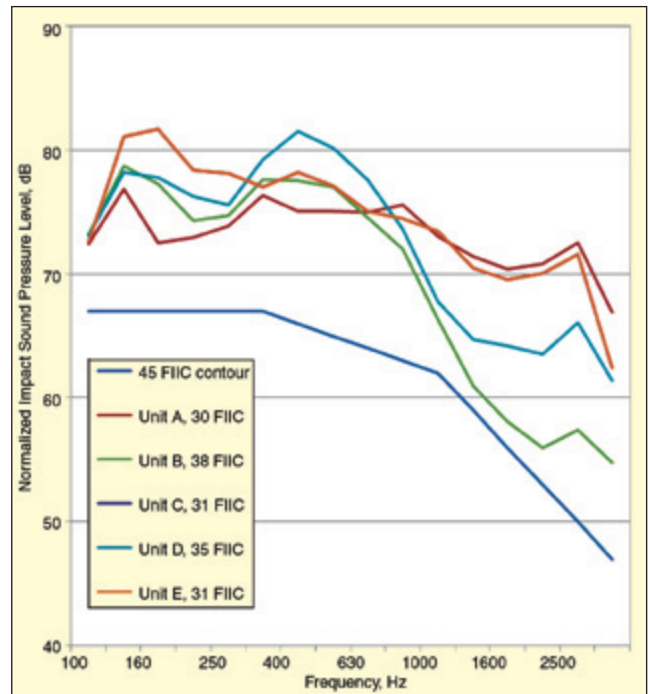
Field testing (Units A and B shown in Figure 1) was first conducted for two floor/ceiling systems with results of 30 and 38 FIIC. Each condo has the same layout, with a large great room (including the foyer, kitchen, dining room, and living room), three bedrooms, and two bathrooms. FIIC testing was limited to the great room, since it was the only room which met the minimum volume requirement listed in ASTM E 1007.*

Figure 1. Pre-mitigation FIIC ratings of tested condo units.

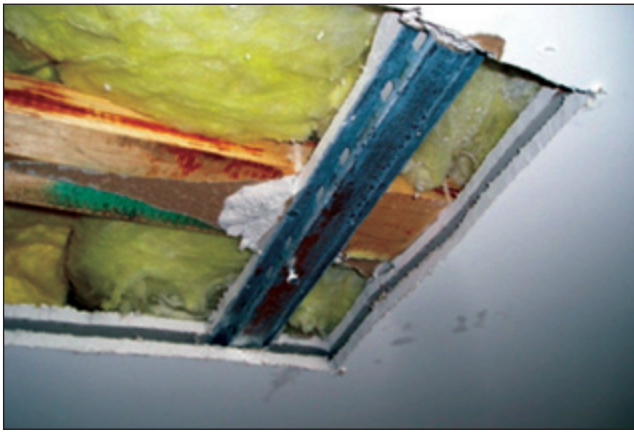
An investigation was conducted in several condo units by removing sections of ceiling gypsum board, revealing resilient channel “sandwiched” between the layers of ceiling gypsum board (see Figure 2) and double-screwed resilient channel (see Figure 3). Following the investigation, it was revealed that the local fire marshal had required resilient channel to be installed in this way for fire safety reasons, and that two flooring contractors had been used for the buildings. These contractors had used unknown underlayments that may not have been the underlayments listed in the building’s architectural details.

Figure 2. Resilient channel “sandwiched” between layers of gypsum board in original ceiling.

Since resilient channel was known to be installed incorrectly and would need to be removed and replaced anyway, modifying the ceiling design was a more sensible approach than trying to address the problem by correcting only the floor or both the ceiling and the floor. This decision was supported by the conjecture that when evaluated separately, a feasible ceiling could be designed to sufficiently resolve the problem, while the same could not be said about the performance of a feasible floor modification alone.

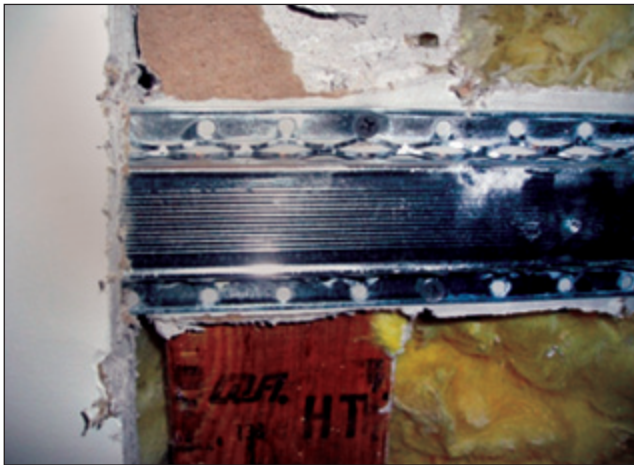
Figure 3. Double-screwed ceiling resilient channel (in original ceiling).

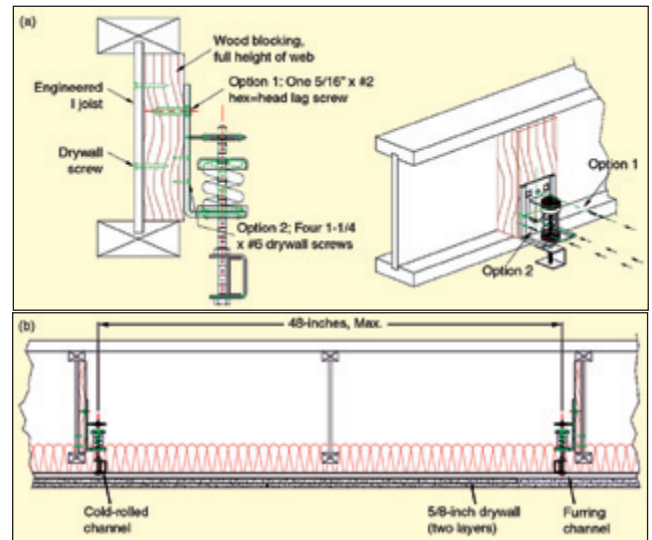
Figure 4. Spring and grid installation (courtesy of Kinetics Noise Control).

Option 3 was selected due to the highest expected performance of the three. Following the selection of a remedial design option, spring-load calculations were completed to ensure proper load distribution throughout the entire grid system, verifying that no spring would be over- or under-loaded when accounting for the weight of the sound-engineered drywall and the grid structure materials. (The spring layout design was confirmed by the spring manufacturer; see Figure 4 for spring installation details.)

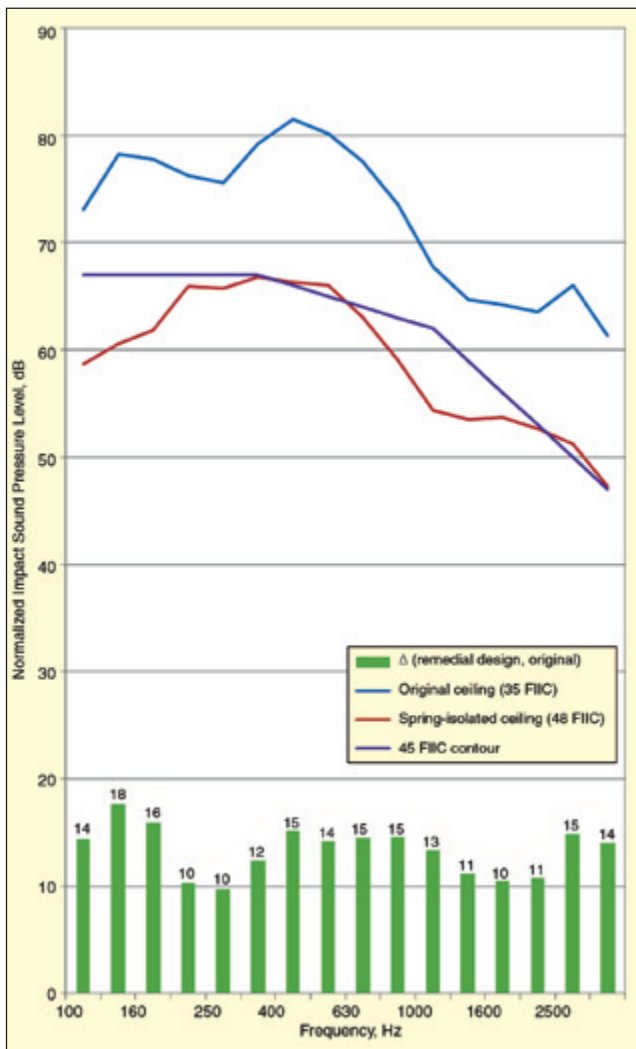
Post-Mitigation Testing. FIIC ratings of the three prototype units were measured one week after the pre-gypsum board inspections, revealing FIIC ratings of 48, 49, and 48, and FIIC value increases of 13, 18, and 17, respectively. (Pre- and post-mitigation data are shown in Figures 5, 6, and 7.) Each of the three prototype units

Figure 5. Pre- and post-mitigation test results (Unit C).

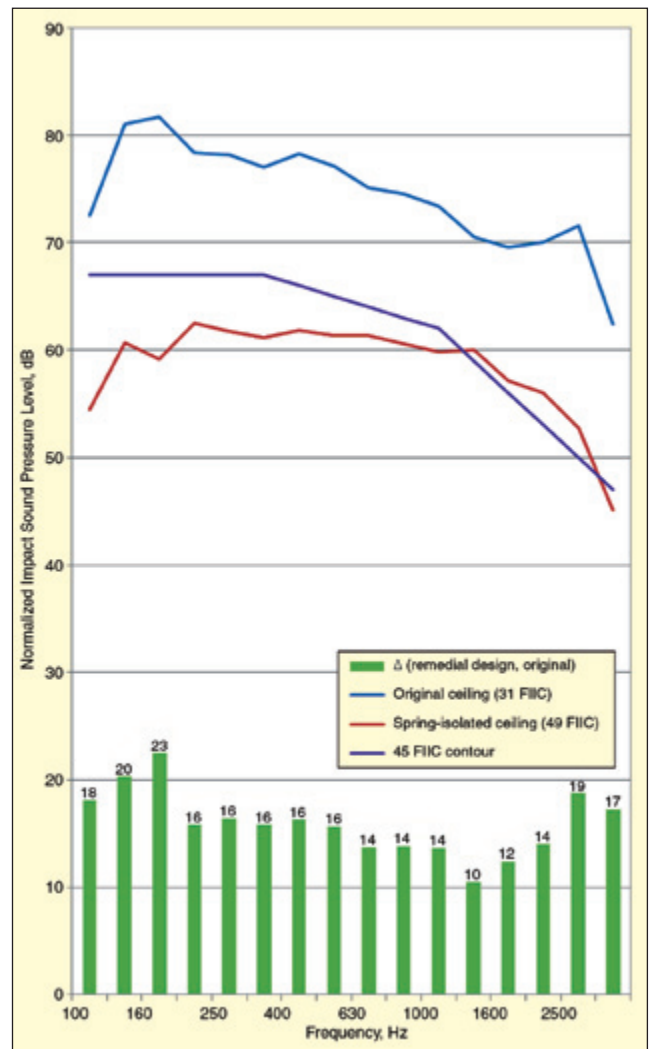
Figure 6. Pre- and post-mitigation test results (Unit D).

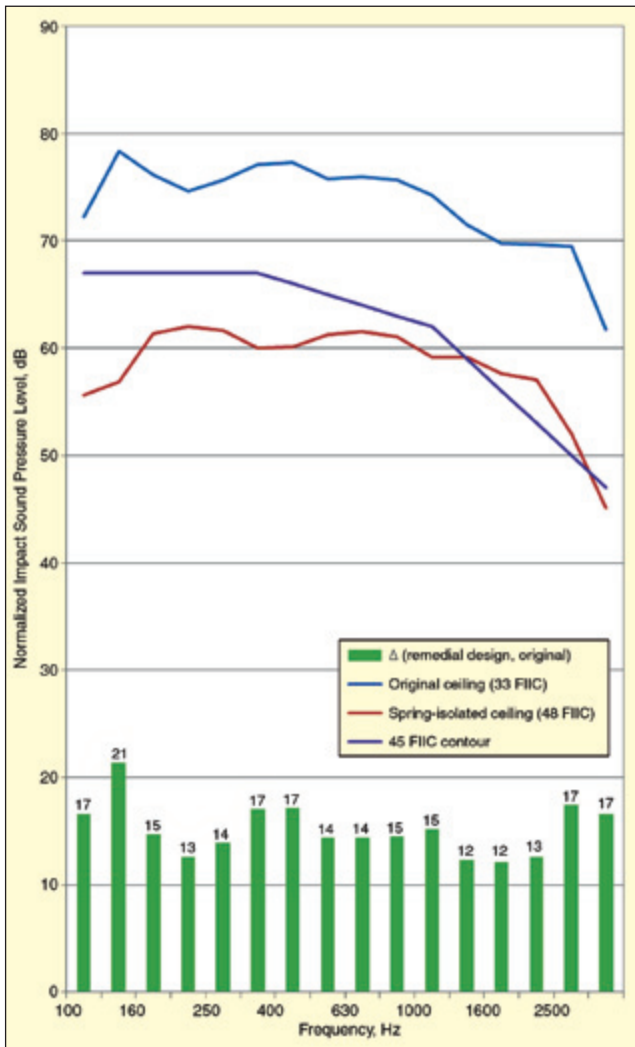
Figure 7. Pre- and post-mitigation test results (Unit E).

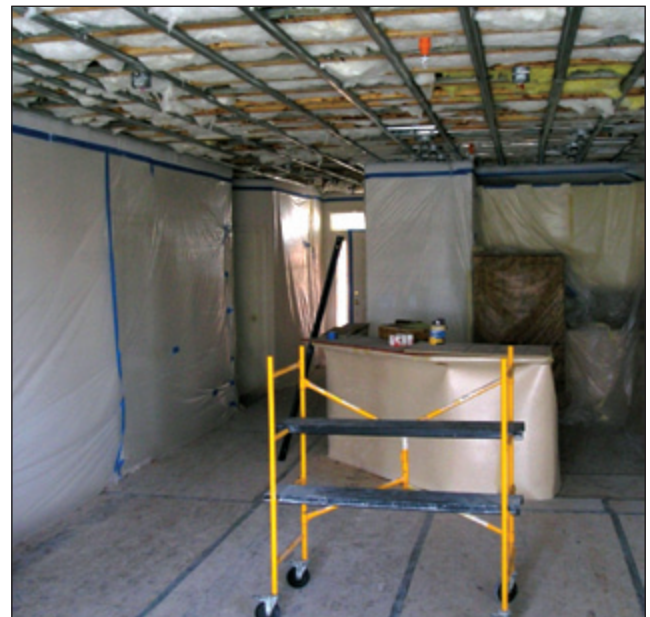
Figure 8. Existing ceiling demolition and spring isolated ceiling installation.

Demolition and Installation. After removing all condo possessions, all remaining condo surfaces and fixtures were protected. Walls were covered in plastic, plywood sheets were laid over all flooring, and cabinets, and sinks, toilets, etc. were boxed in with plywood (see Figure 8). The existing ceiling was then removed and the springs and spring grid were installed. Following the inspec-
