## **Increasing impact insulation ratings in occupied condominium buildings by modifying only the ceiling**

Phoenix Noise & Vibration

**Over 100 condominium units were constructed with a floor/ceiling system consisting of an unidentified “acoustic” floor underlayment and resilient channel sandwiched between two layers of gypsum board, resulting in numerous impact noise complaints from condo owners. After initial Field Impact Insulation Class (FIIC) testing revealed ratings as low as 31 FIIC (required 45 FIIC), remedial mitigation options were developed to meet two design criteria: 1) develop a floor/ceiling system to meet the required Impact Insulation Class rating, and 2) the floor cannot be modified. Three mitigation options were designed before a spring-isolated ceiling system was selected for use in three trial condo units. After the removal of the existing ceiling and prior to the installation of ceiling gypsum board, an inspection was conducted to verify the spring grid was properly installed, followed by post-mitigation testing revealing FIIC ratings of 48 to 49. Following the successful test results and satisfied testimonies from the condo owners, a decision was made to r

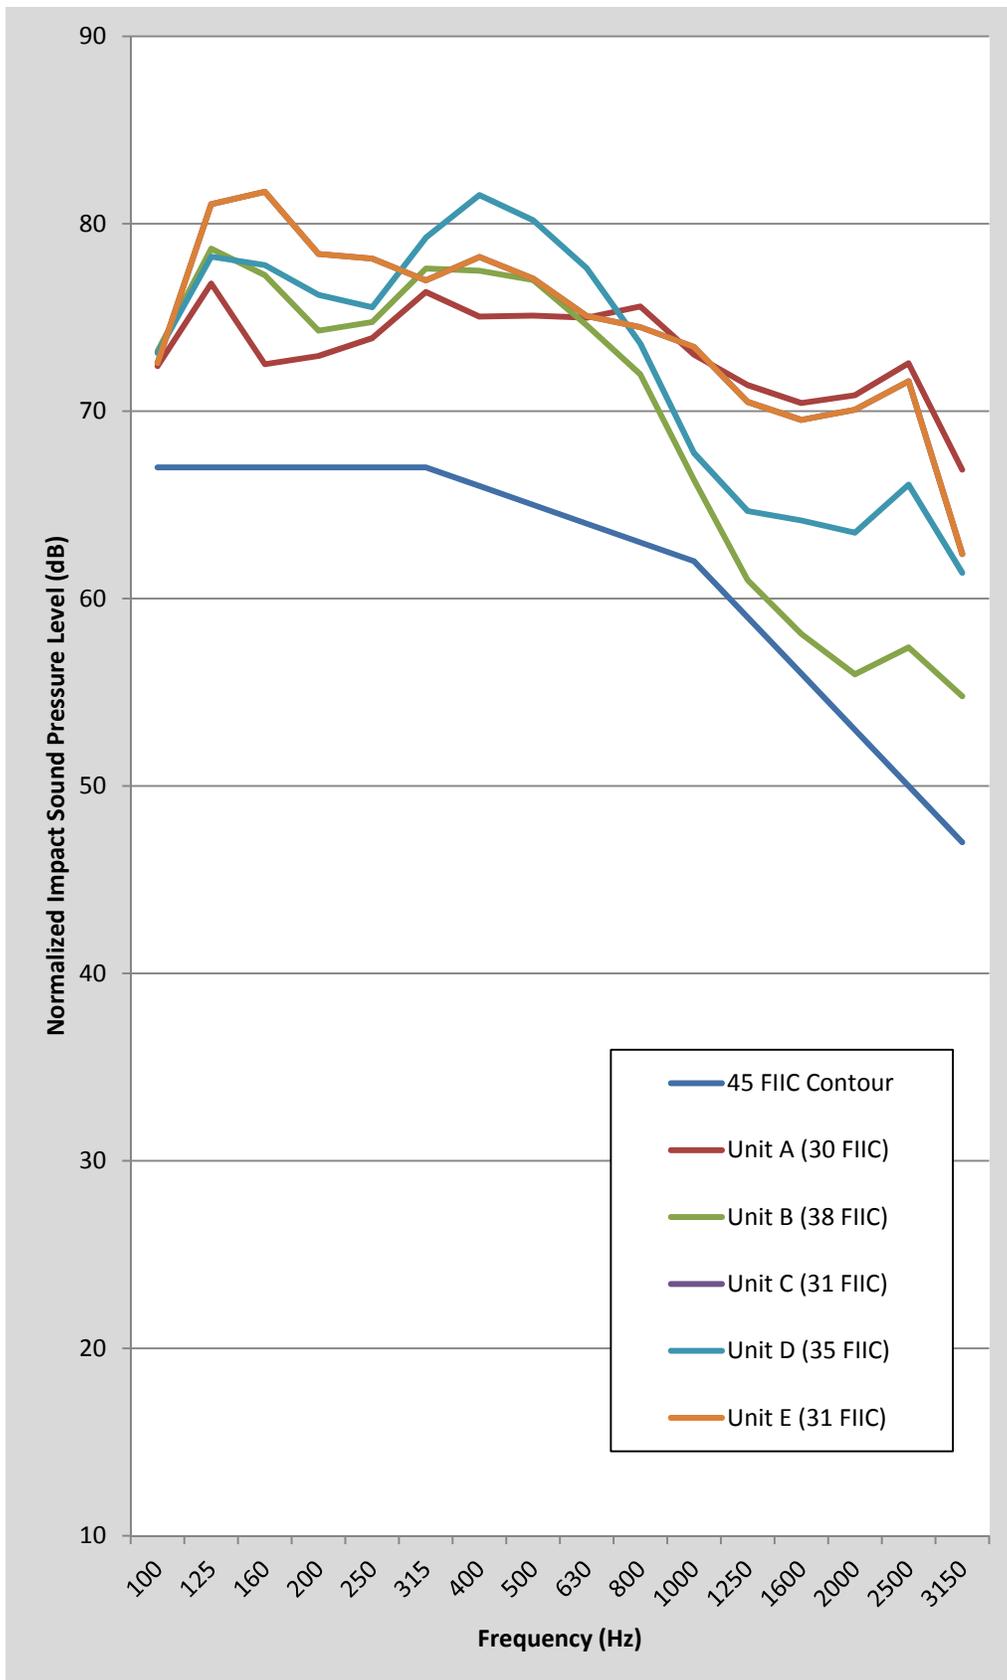
Field testing (Units A and B shown in Figure 1) was first conducted for two floor/ceiling systems with results of 30 and 38 FIIC. Each condo has the same layout, with a large great room (including the foyer, kitchen, dining room, and living room), three bedrooms, and two bathrooms. FIIC testing was limited to the great room since it was the only room which met the minimum volume requirement listed in ASTM E 1007.<sup>1</sup>

Fig. 1 - Pre-mitigation FIC ratings of tested condo units.

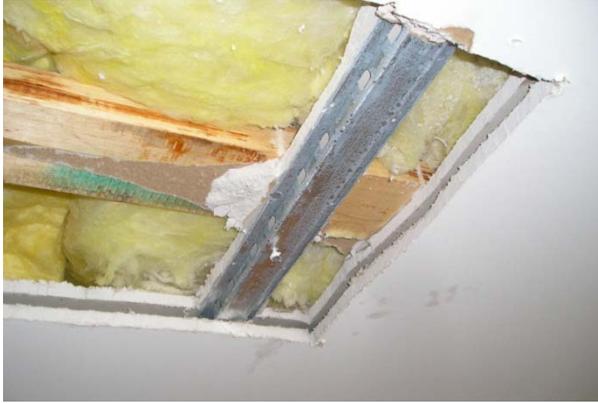
An investigation was conducted in several condo units by removing sections of ceiling gypsum board, revealing resilient channel "sandwiched" between the layers of ceiling gypsum board (see Figure 2) and double screwed resilient channel (see Figure 3). Following the investigation, it was revealed that the local fire marshal had required resilient channel to be installed in this way for fire safety reasons, and that two flooring contractors had been used for the buildings. These contractors had used unknown underlayments which may not have been the underlayments listed in the building's architectural details.

Fig. 2 - Resilient channel "sandwiched" between layers of gypsum board in original ceiling.

Since resilient channel was known to be installed incorrectly and would need to be removed and replaced anyway, modifying the ceiling design was a more sensible approach than trying to address the problem by correcting only the floor or both the ceiling and the floor. This decision was supported by the conjecture that when evaluated separately, a feasible ceiling could be designed to sufficiently resolve the problem, while the same could not be said about the performance of a feasible floor modification alone.

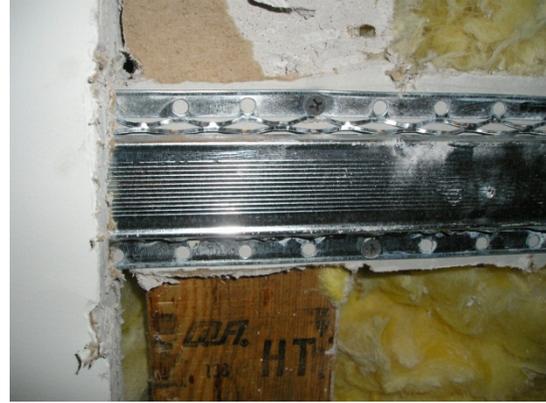
Fig. 3 - Double screwed ceiling resilient channel (in original ceiling).

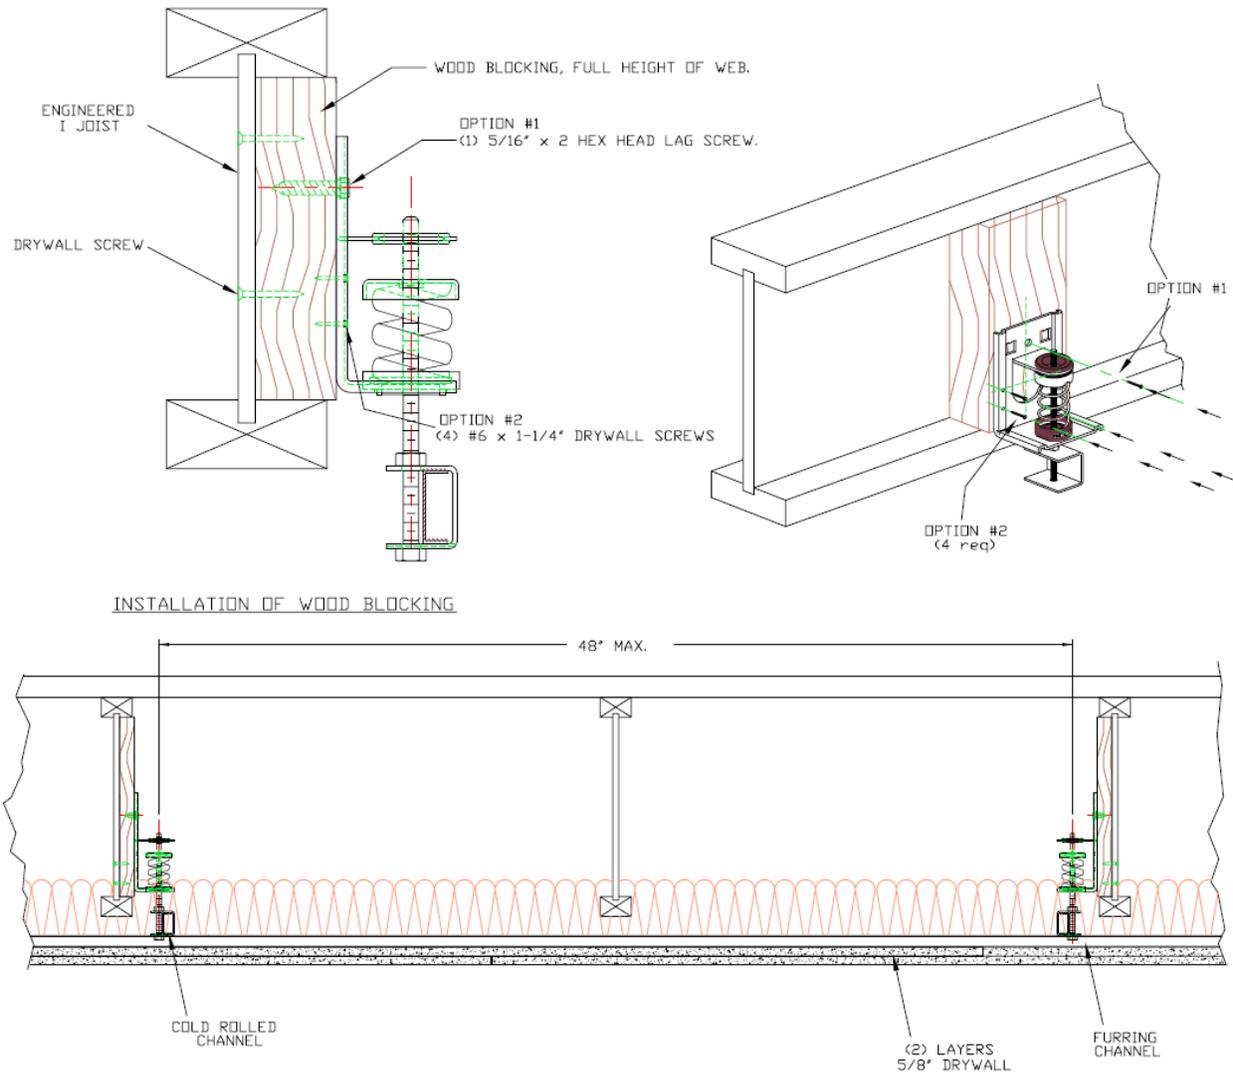
Fig. 4 - Spring and grid installation (courtesy of Kinetics Noise Control).

Option 3 was selected due to the highest expected performance of the three. Following the selection of a remedial design option, spring load calculations were completed to ensure proper load distribution throughout the entire grid system, verifying that no spring would be over or under loaded when accounting for the weight of the sound engineered drywall and the grid structure materials. (The spring layout design was confirmed by the spring manufacturer. See Figure 4 for spring installation details.)

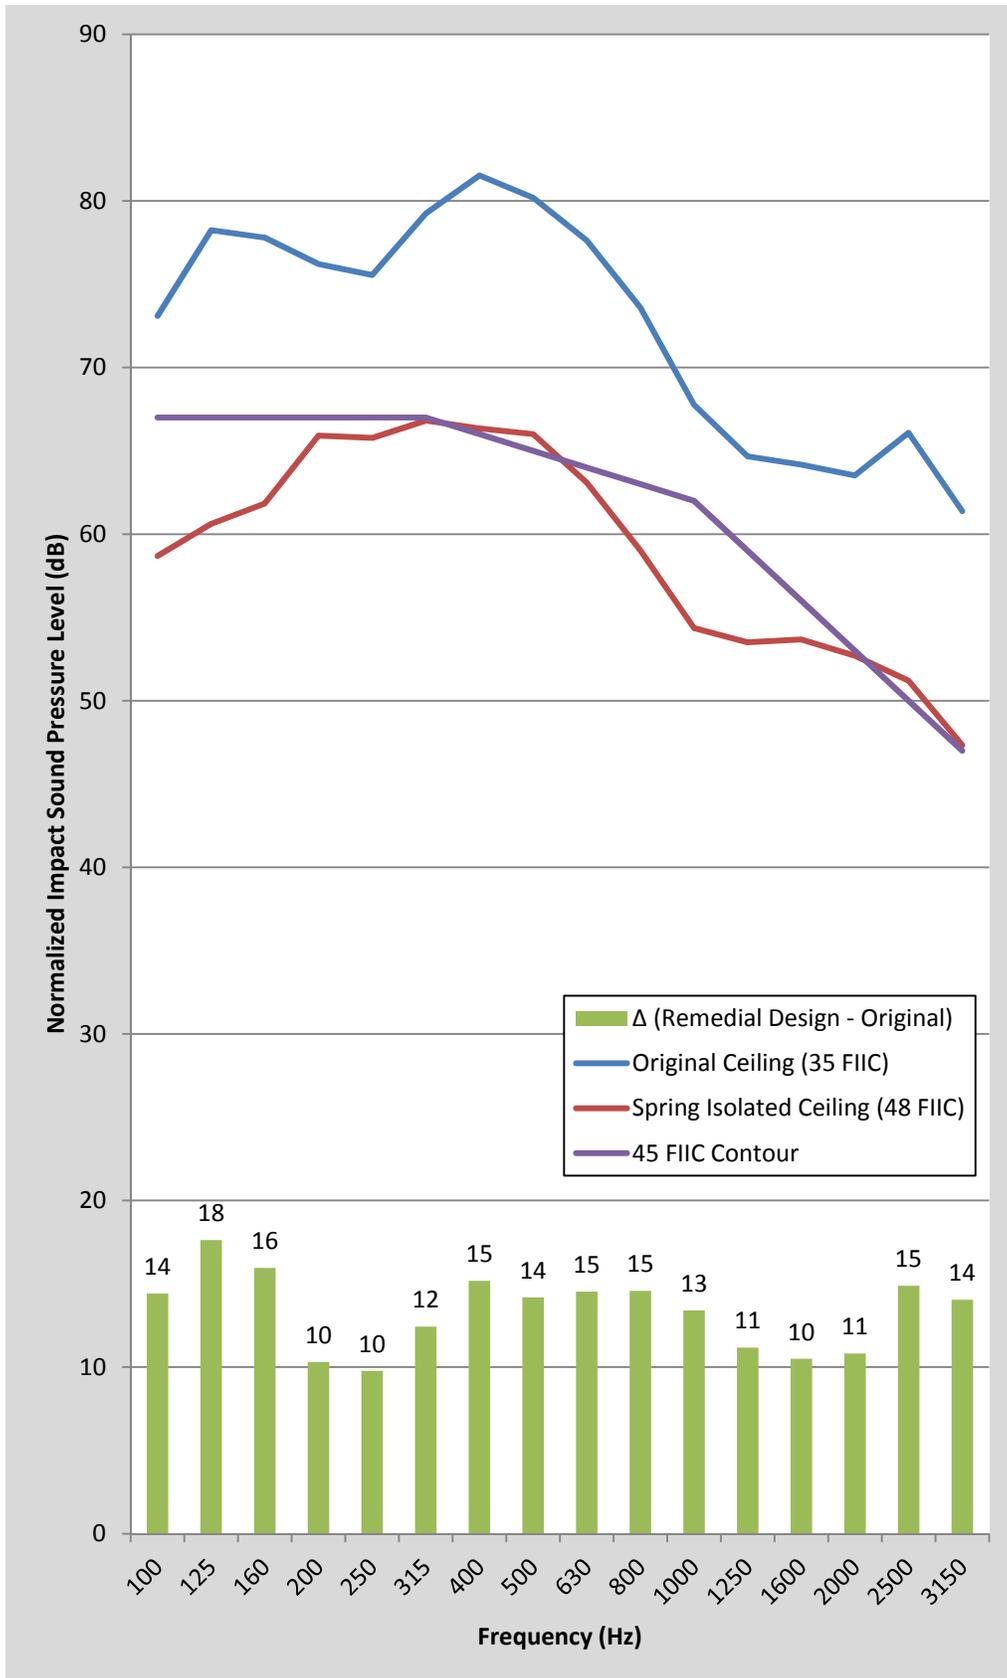
FIIC ratings of the three prototype units were measured one week after the pre-gypsum board inspections, revealing FIIC ratings 48, 49, and 48, and FIIC value increases of 13, 18, and

17, respectively. (Pre- and post-mitigation data is shown in Figures 5, 6, and 7.) Each of the three prototype units now met the building's 45 FIIC requirement.

Fig. 5 - Pre- and post-mitigation test results (Unit C).

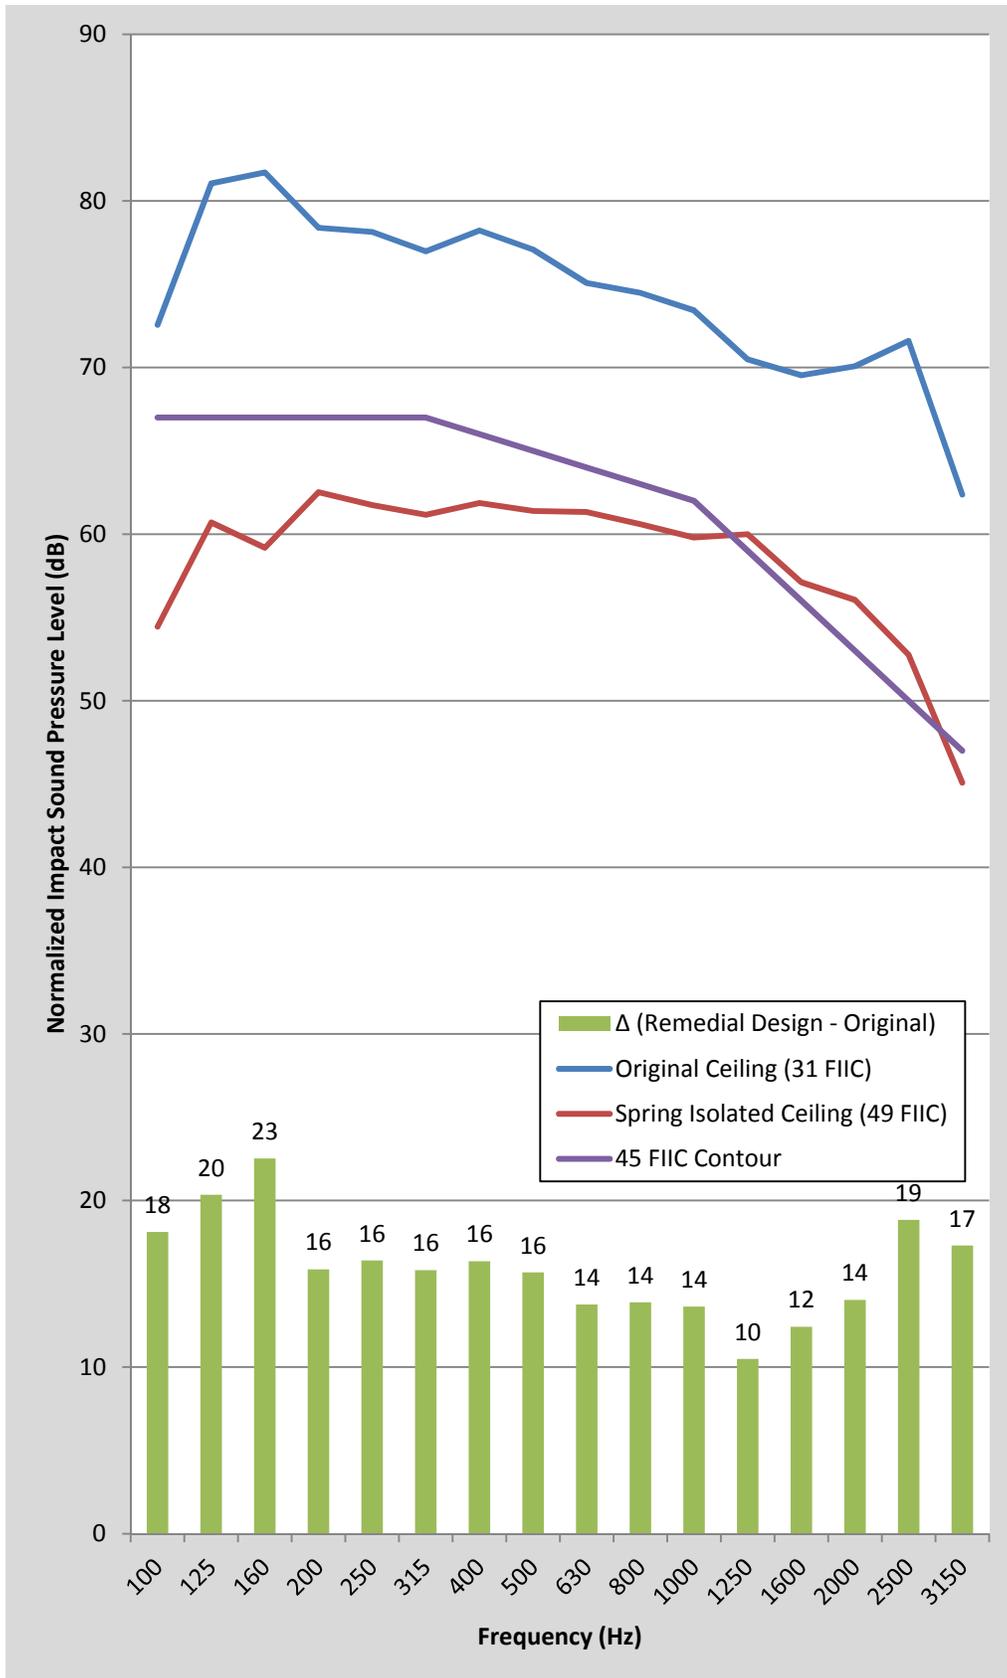
Fig. 6 - Pre- and post-mitigation test results (Unit D).

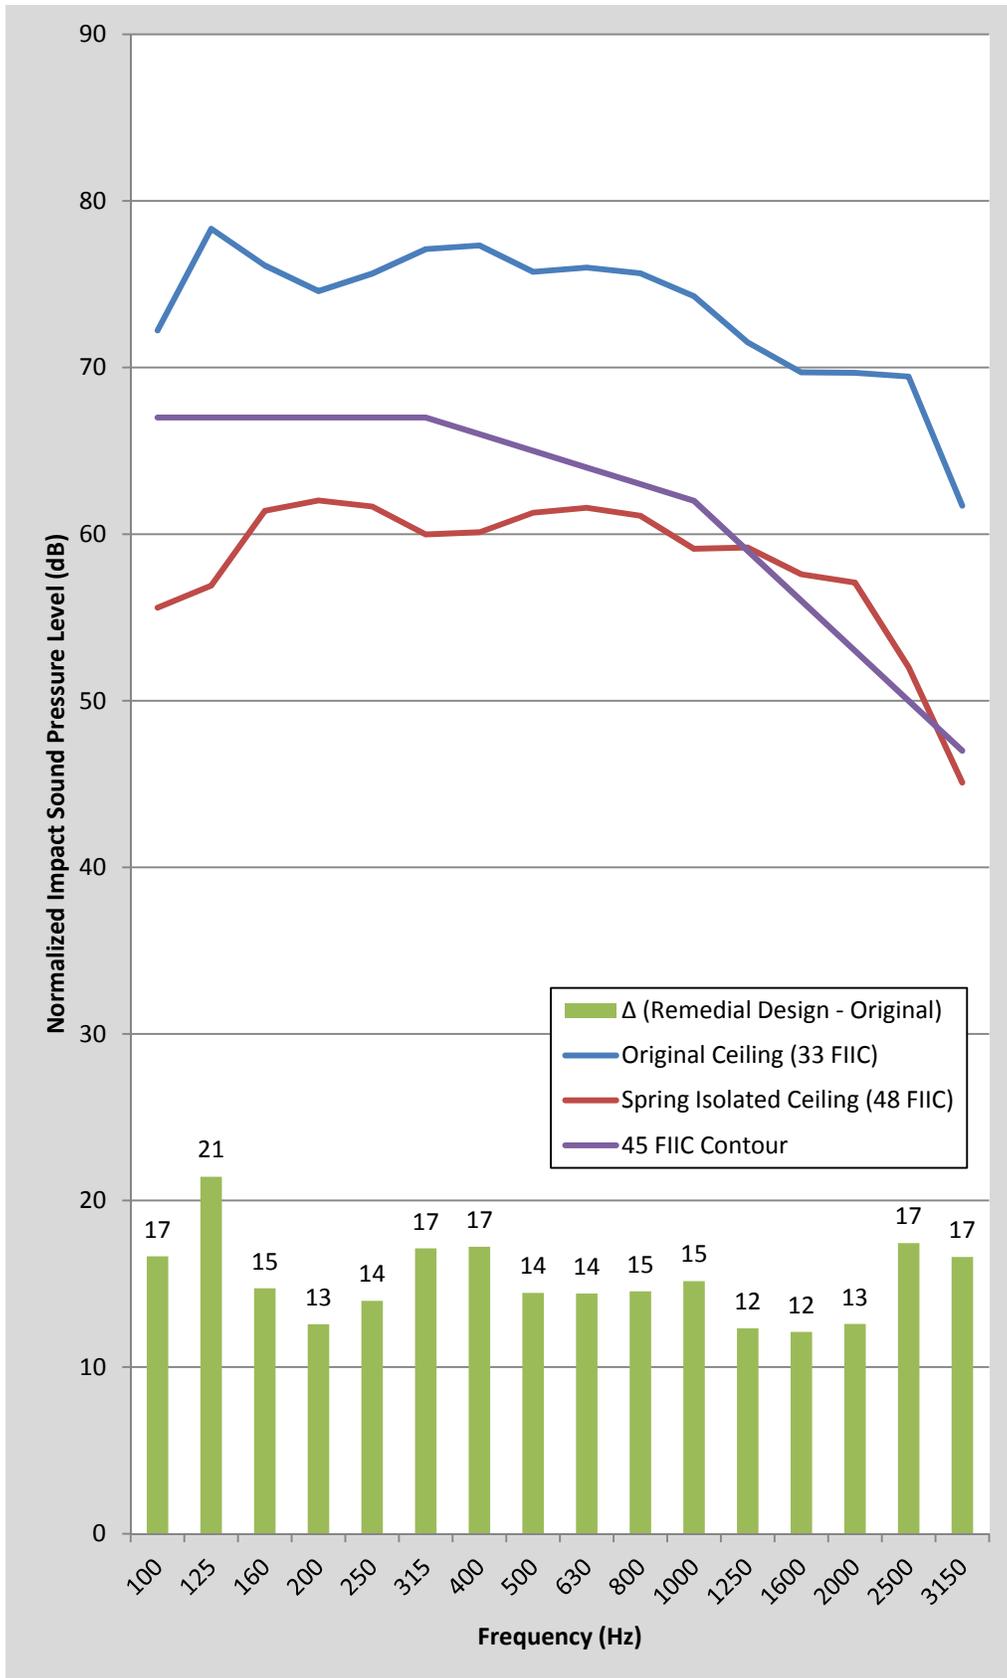
Fig. 7 – Pre- and post-mitigation test results (Unit E).

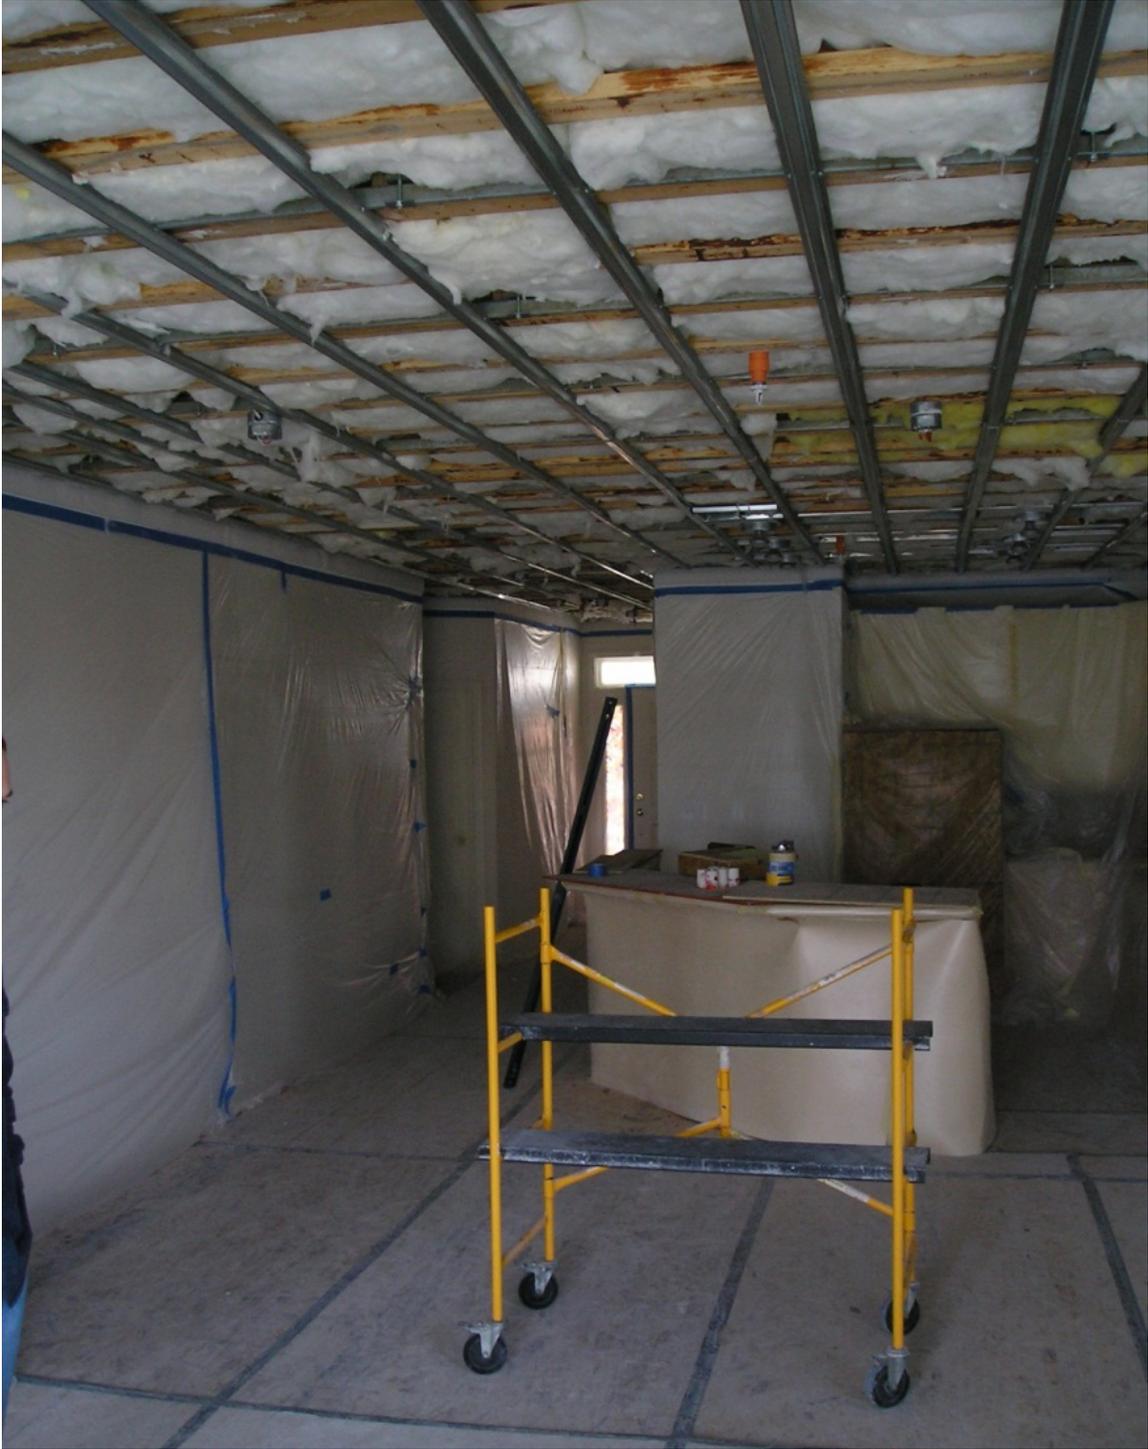
*Fig. 8 – Existing ceiling demolition and spring isolated ceiling installation.*

After removing all condo possessions, all remaining condo surfaces and fixtures were protected. Walls were coved in plastic, plywood sheets were laid over all flooring, and cabinets, and sinks, toilets, etc. were boxed in with plywood (see Figure 8). The existing ceiling was then removed and the springs and spring grid were installed. Following the inspection of the grid system, ceiling gypsum board was installed and the entire ceiling was painted.
