Retrofit structural insulated panels (SIPs) increase sound transmission loss of existing single family houses impacted by highway noise

Scott Harvey^a
Phoenix Noise & Vibration
5216 Chairmans Court, Suite 107
Frederick, MD 21703

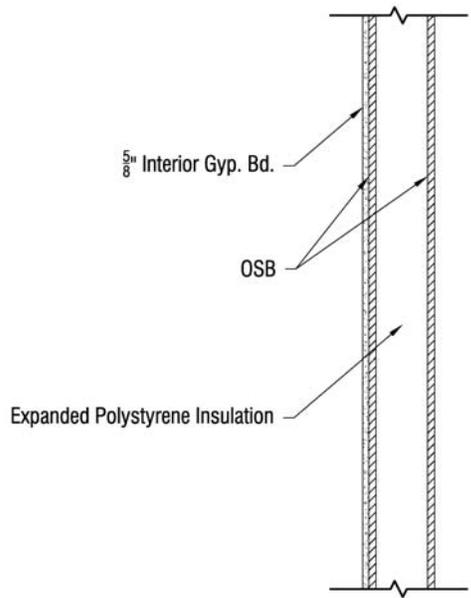
Figure 1: Typical Structural Insulated Panel (SIP) section.

STC-29

A standard SIP panel with one layer of 1/2 inch drywall attached to the interior face achieves a 29 STC rating. Conventional 2x4 wood stud construction achieves a 36 STC rating.

Occupants of a newly constructed residential development complained of excessive traffic noise within their single family units. Instead of conventional 2x4 wood stud construction, the houses were constructed using Structural Insulated Panels (SIP). The SIPs are composed of 3.5 inches of expanded polystyrene insulation sandwiched between two layers of oriented strand board (OSB) and exhibit higher thermal efficiency than conventional construction. Figure 1 shows a cross section of a typical SIP. SIPs are shipped to a site as a unit and reduce construction time of exterior walls. While beneficial for thermal insulation and ease of construction, the SIP panel system does not perform as well acoustically as conventional 2x4 wood construction. When compared to conventional construction, sound transmission testing of the raw SIP panel reveals an overall reduction at most frequencies with a significant reduction in the 600 Hz range.¹ A comparison between the two transmission loss curves is shown in Figure 2.^{2,3} Windows and doors used in the construction were also deficient in transmission loss characteristics.

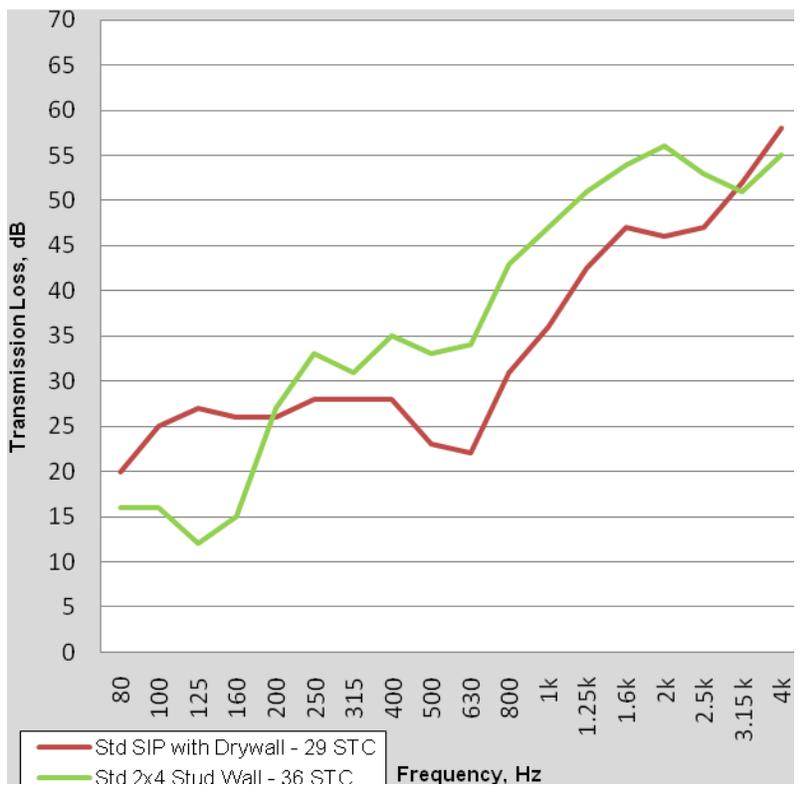
Figure 2: Transmission loss comparison of SIP and standard 2x4 construction.

Subjectively, the noise level in the house had a clear tonal quality which added an annoyance factor to the noticeable traffic noise. Normally traffic noise has a fairly broadband characteristic; however with a notable dip at the 630 Hz band the SIP transmission loss spectrum acts as a band pass filter to the broad band noise producing the tonal character of the interior noise.

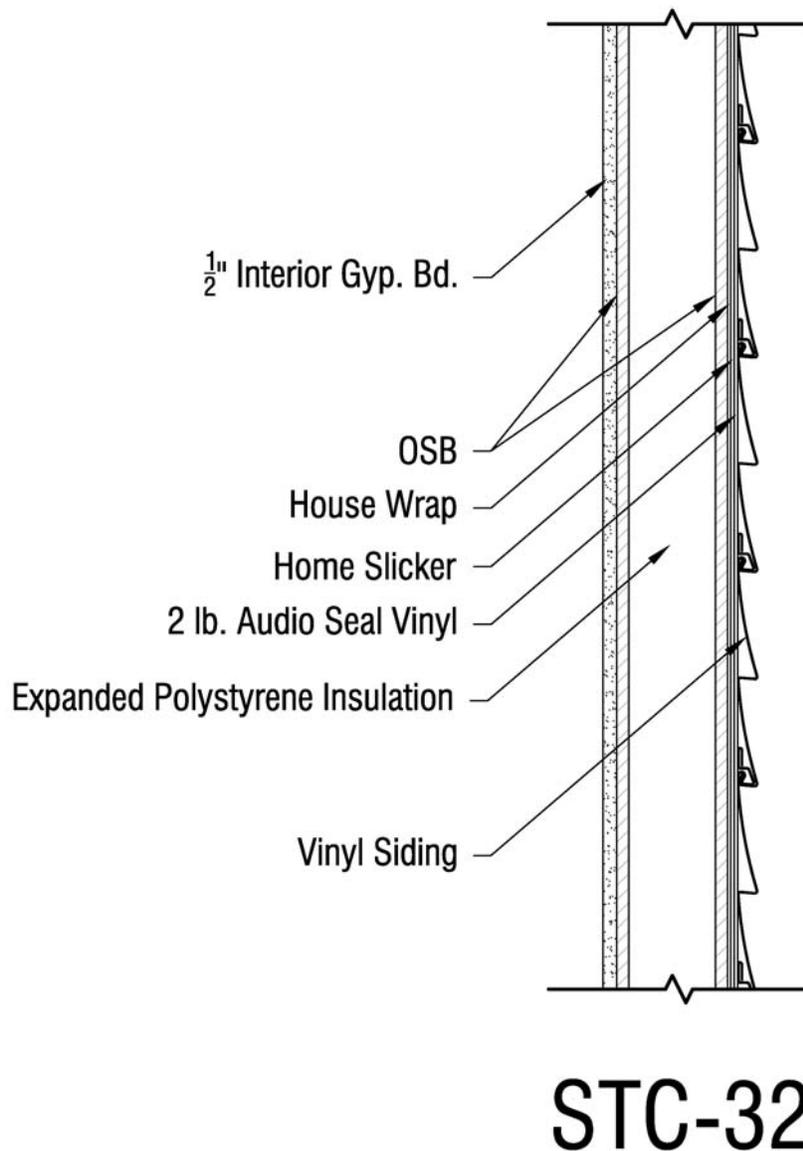
Figure 3: SIP modified with 2 lb/ft² loaded vinyl.

Two options of wall remediation were recommended and tested for performance. The first option involved removal of the exterior vinyl siding and attaching a layer of home slicker, house wrap, and loaded vinyl sheeting (2 lb/ft²) to the face of the SIP panel. The vinyl siding was then reinstalled. These additional layers were simply screwed to the SIP at 12 inches on center. This modification provided a "Level One" increase in the walls transmission loss. This option

increased the rating of the SIP from 29 STC to 32 STC.⁵ This option was used for houses which required less noise reduction than other houses impacted by higher noise levels. See Figure 3 for a cross section of the construction.

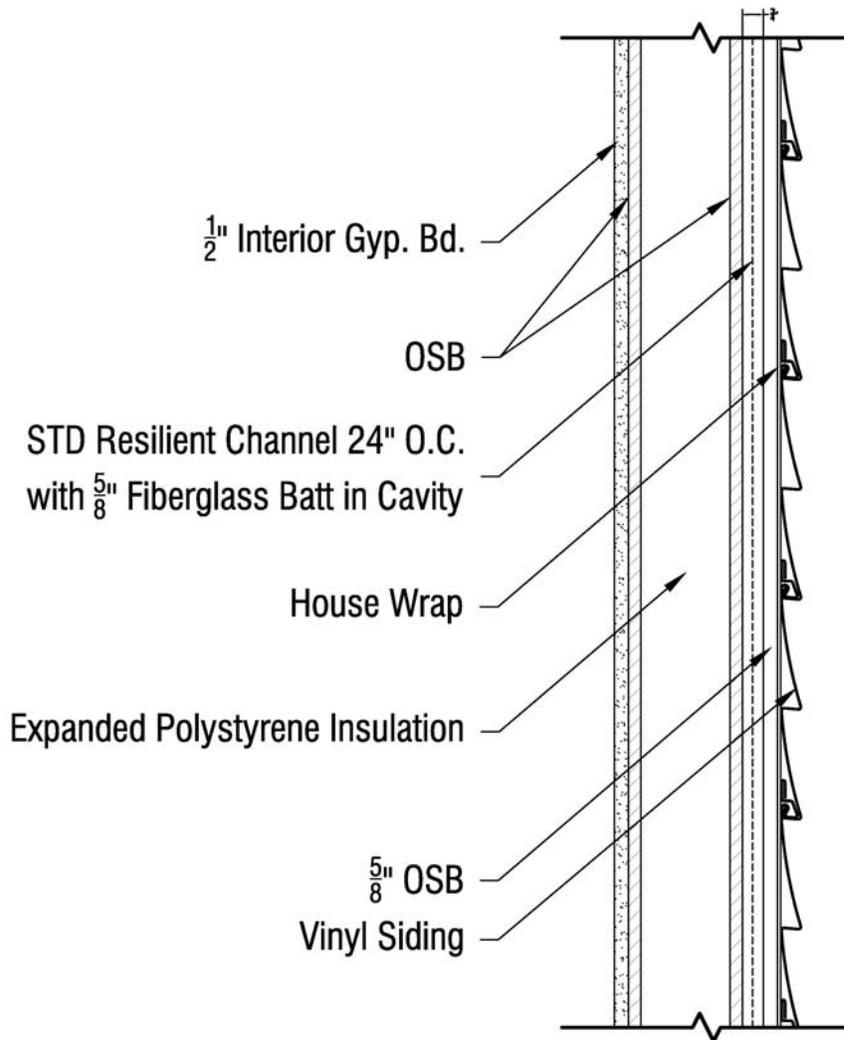
Figure 4: SIP modified with OSB and resilient channel.

The second option, “Level Two”, was more complex but provided a substantially greater increase in the transmission loss of the system. This involved removing the vinyl siding and installing resilient channel, fiberglass batt insulation, a single layer of 5/8 inch oriented strand board, house wrap and reinstallation of the vinyl siding. This option increased the rating of the SIP from 29 STC to 43 STC and was used for houses exposed to higher noise levels.² See Figure 4 for a cross section of the construction.

STC-43

The resilient channel solution is quite unique from traditional acoustical construction. First, for moisture control, the resilient channel was mounted vertically as opposed to horizontally. This allowed moisture to drip down the wall and weep out as opposed to collecting in the joint between the resilient channel and the base layer OSB. Secondly, with this configuration, the

resilient channel is “sandwiched” between two layers of OSB. With more traditional gypsum board applications, “sandwiching” resilient channel is strongly discouraged. This configuration restricts the resilient channel, negating its effectiveness may produce unfavorable resonances in the system. In instances where resilient channel is “sandwiched”, the installation of fiberglass batt between the channels is also uncommon.

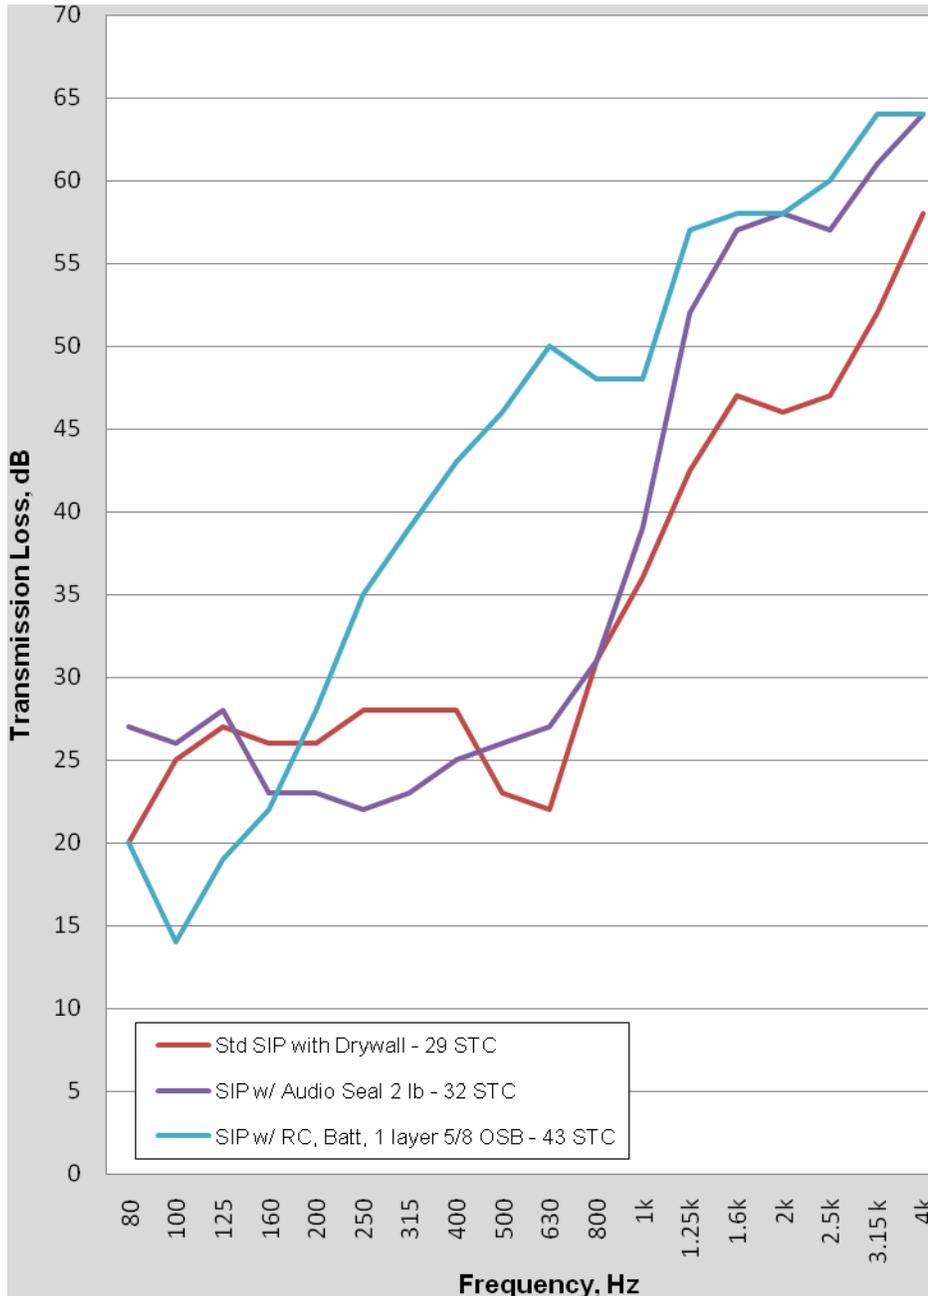
Figure 5: Transmission loss comparison of 3 SIP constructions.

A comparison of the transmission loss values of the three wall systems is shown in Figure 5. While the mass loaded vinyl (Option 1) modification provides significant high frequency improvement and slight improvement at the 600 Hz range there is actually reduction in some frequencies below 400 Hz. The transition from frequency to frequency is smoother and without dips, providing a less tonal character to the interior noise, and an overall increase from 29 to 32 STC. On the other hand, the resilient channel/OSB modification provides significant increase in at all frequencies except those below 200 Hz. Most notable is the increase in the 630 Hz band. Again, there is a fairly smooth transmission from frequency to frequency. Overall the STC rating increases from 29 to 43.

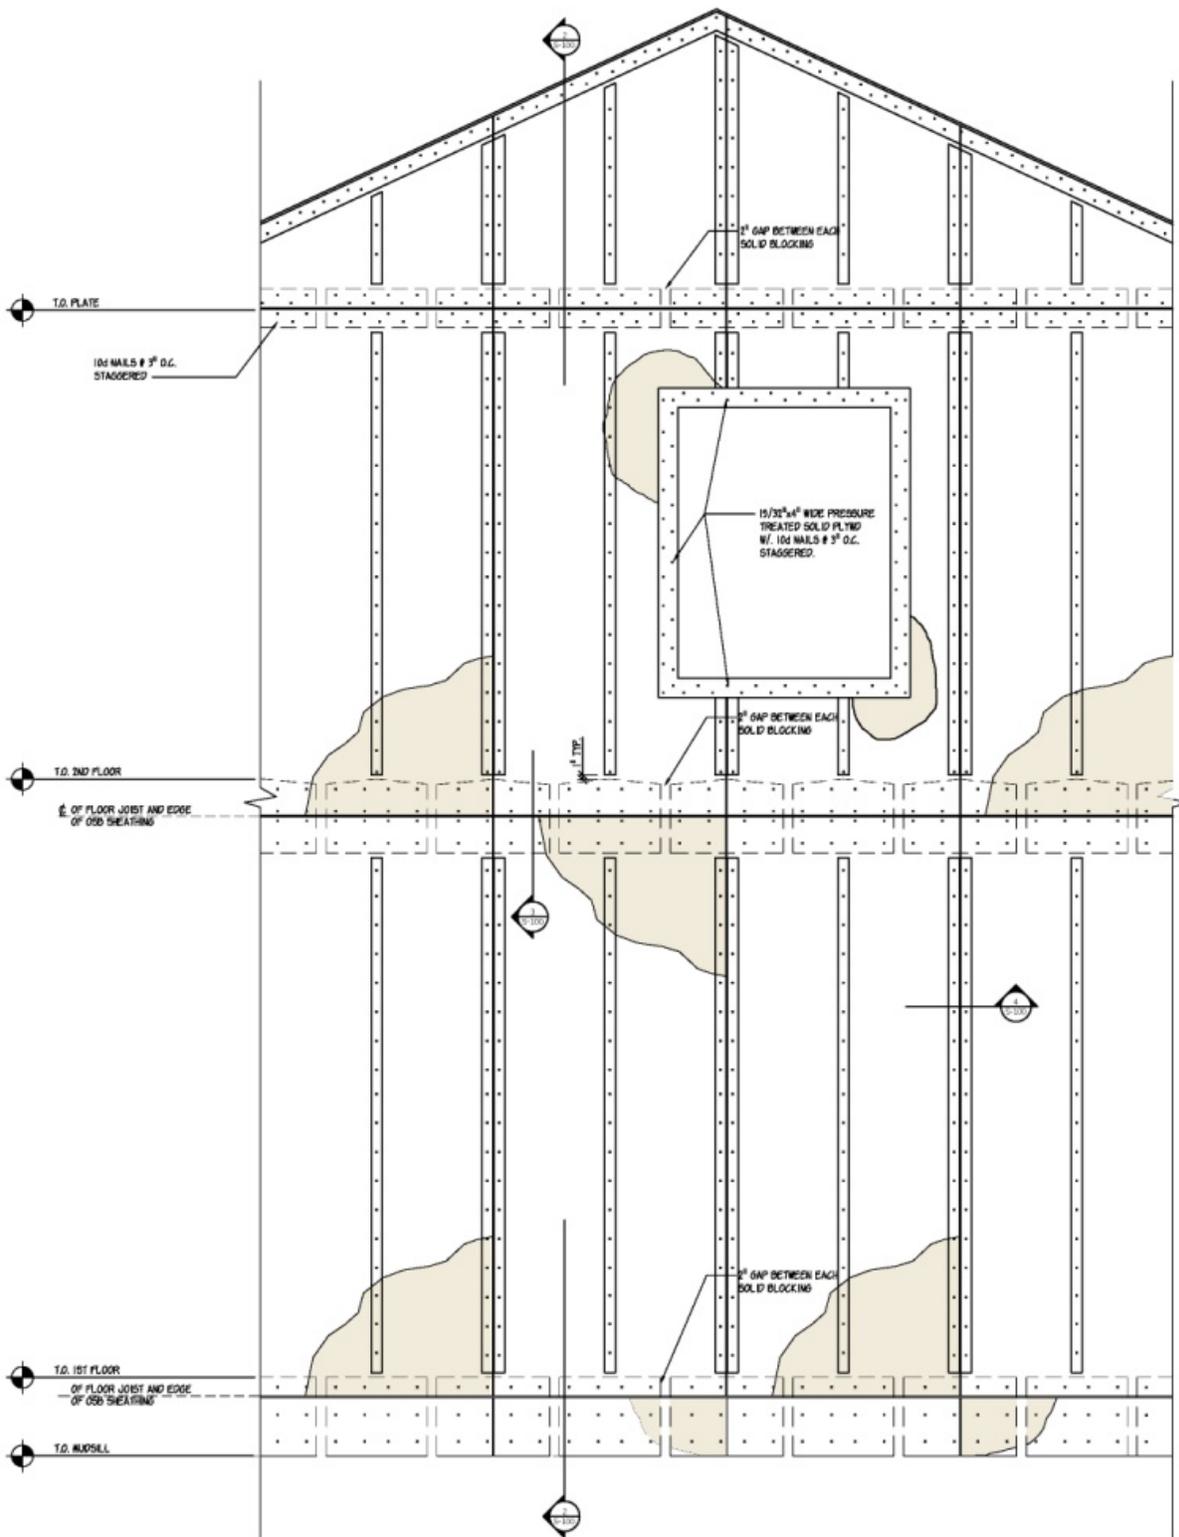
Figure 6: Conceptual resilient channel layout.

A conceptual layout of the resilient channel option (Option 2) is shown in Figure 6. Photographs are also provided showing actual field construction of both the loaded vinyl (Option 1) and the resilient channel options in Figures 7 –10.

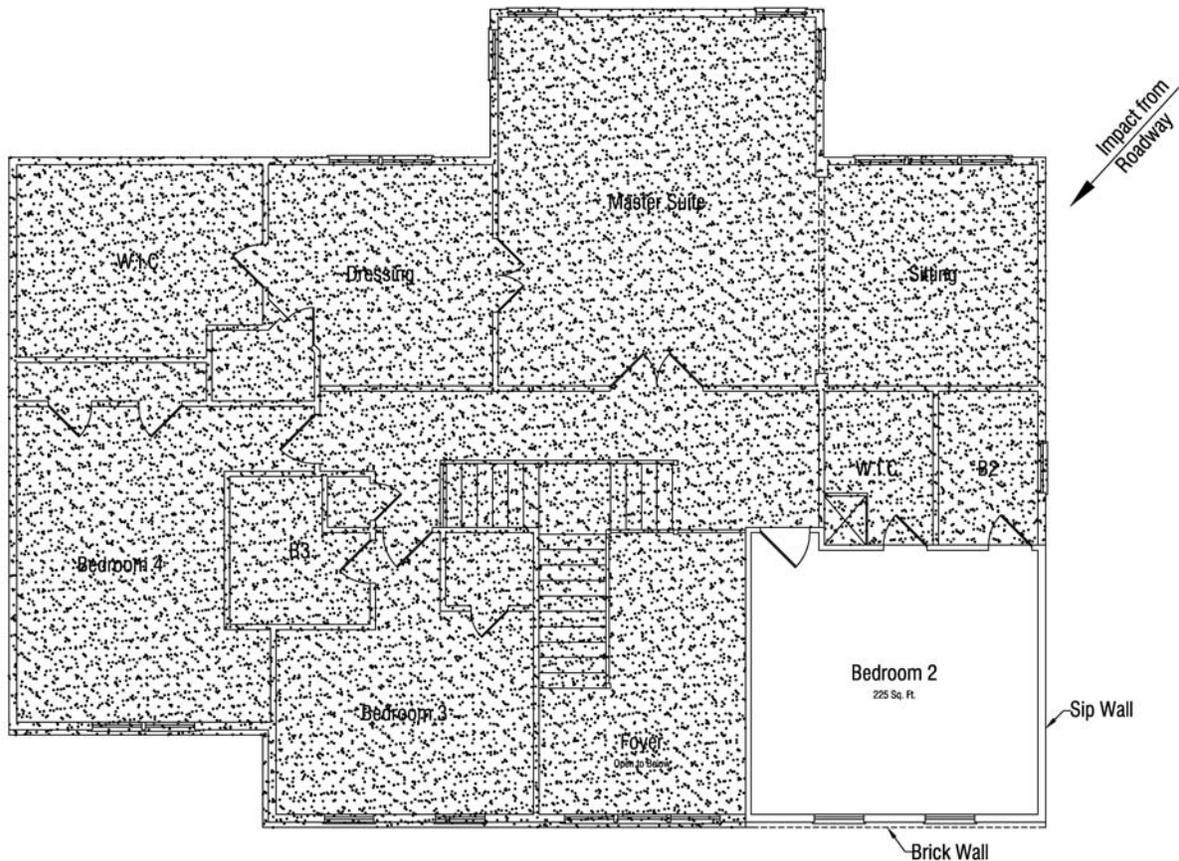
Figure 11: Floor plan showing subject bedroom relative to roadway impact.

A single room will be used as an example in this paper. This upper level bedroom was located in the front corner of the house with the side fully exposed to roadway noise. The front of the building faced away from the roadway and received less impact than the side due to shielding from the house. A floor plan of the house is shown in Figure 11. The front wall of the room was faced in brick and has two windows, while the side wall is SIP construction and has no windows. In the pre-construction condition it was very evident to the listener that the traffic noise in the room came through the SIP wall. The tonality of the noise was also present.

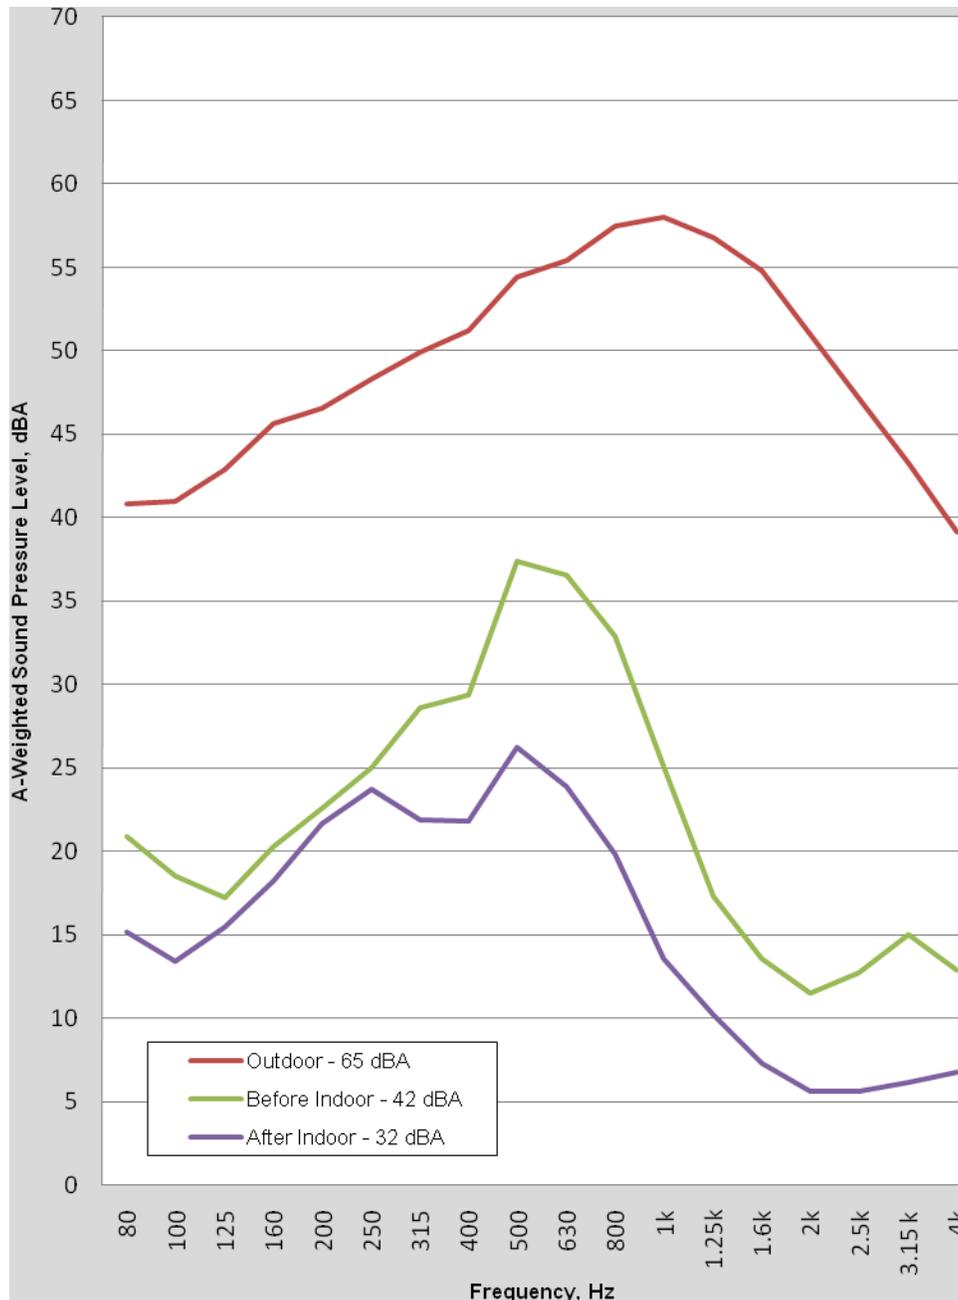
Figure 12: Comparison of Before and After interior, A-weighted noise levels.

Results of the before and after conditions within the subject bedroom are presented in Figure 12. To show how the human ear responds to the noise level, the A-weighted frequency values are plotted. The common outdoor noise level is also plotted, also A-weighted, from which the interior noise levels were determined based upon the calculated OILR.

The tonality of the before condition is clearly evident in the 500 and 630 Hz bands. Also notable is the significant reduction at these frequencies in the after condition. Significant reduction was also experienced in the high frequency range. A 10 dBA reduction in the overall noise level was experienced in this bedroom.
